JORDAN PHOSPHATE MINES COMPANY ESHIDIYA WELLFIELD 21 WELL REHABILITATION PROJECT

INTRODUCTION

California-based WellJet recently teamed up with Jordanian partner KAC (Khost Aqua Consulting) to rehabilitate the 21 wells supplying the Eshadiya facility for JPMC (Jordan Phosphate Mines Company).

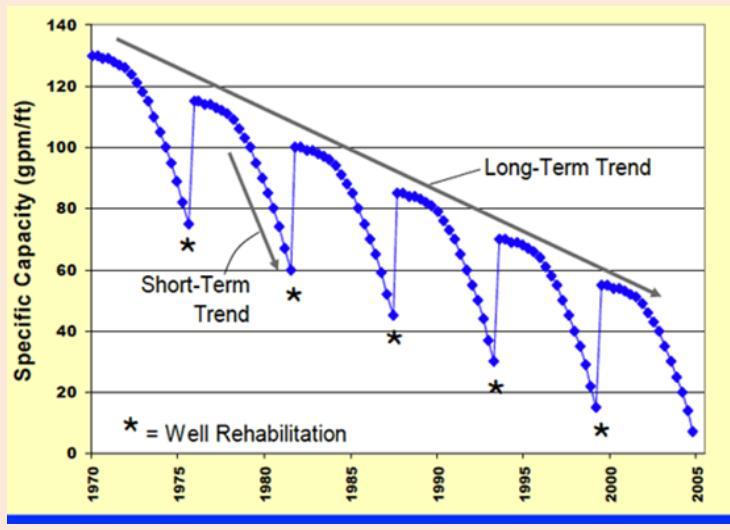
WRD Technical Bulletin (Specific Capacity), Ted Johnson

The wells, in operation for 25 years, exhibited a declining flow rate and efficiency profile consistent with the industry-accepted generic profile shown at right:

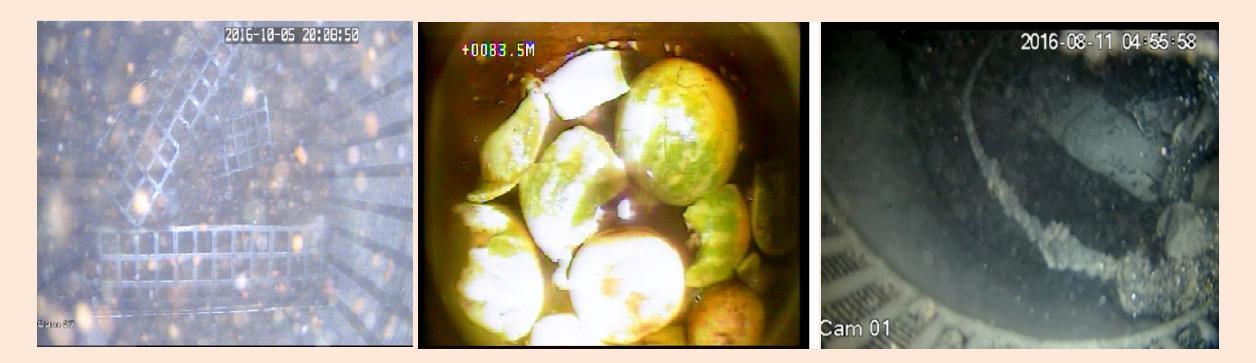
Since the Eshidiya facility requires water from at least 14 wells to keep operating, WellJet/KAC began by rehabilitating 7 wells that were currently out of service for various reasons – including foreign objects that had become lodged downhole:

Some of these foreign objects were fished out by KAC. For those that could not be fished out, WellJet (US Patent No. 8,312,930) high-pressure waterjetting tools were utilized to pulverize.

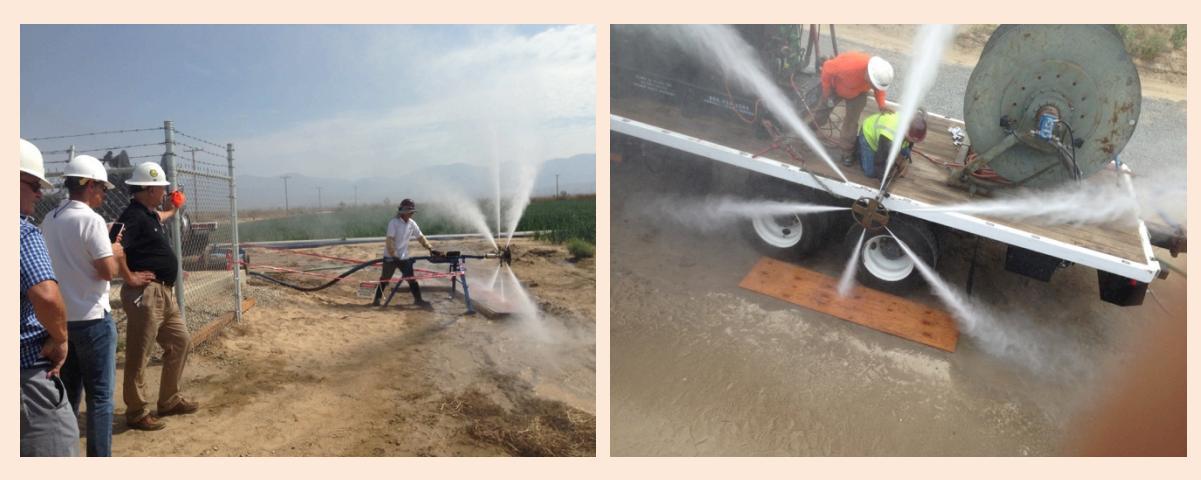
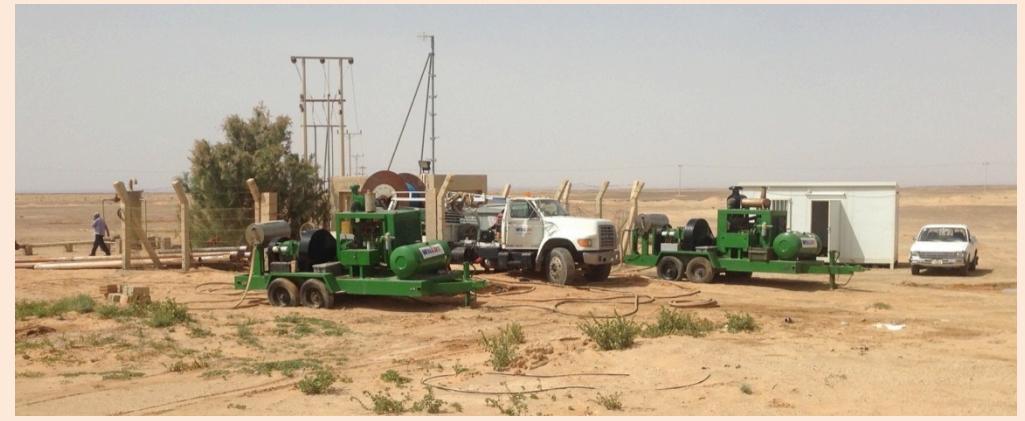
WellJet operations at JPMC Eshidiya wellfield

Once the obstacles were cleared, jetting began. WellJet utilizes highly pressurized water in a laminar flow to remove encrustation inside the well casing, open plugged perforations, and penetrate into the gravel pack to break up harmful deposits that impede water flow. Jetting starts at the bottom of the perforated area, and continues throughout the production zone to ensure that 100% of perfs are jetted.

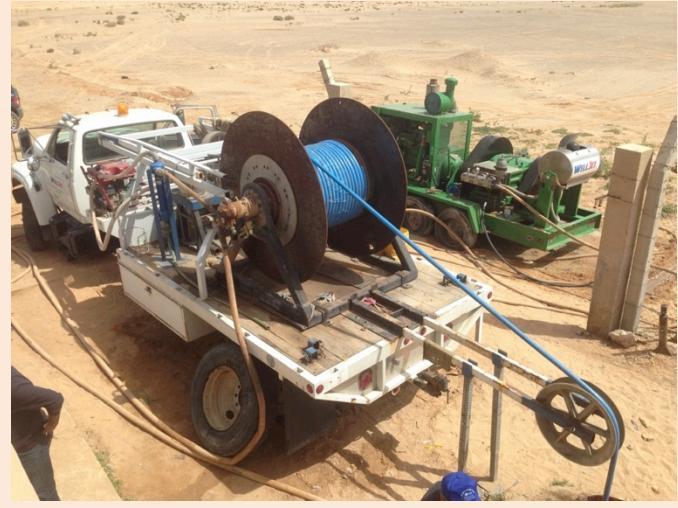
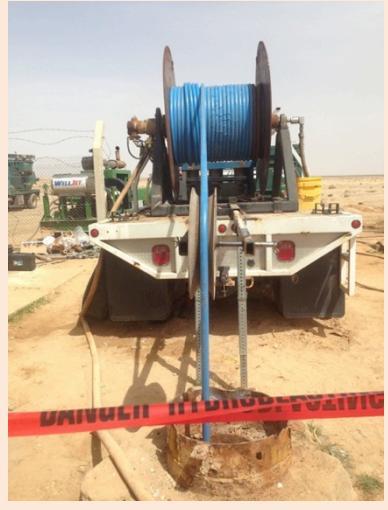
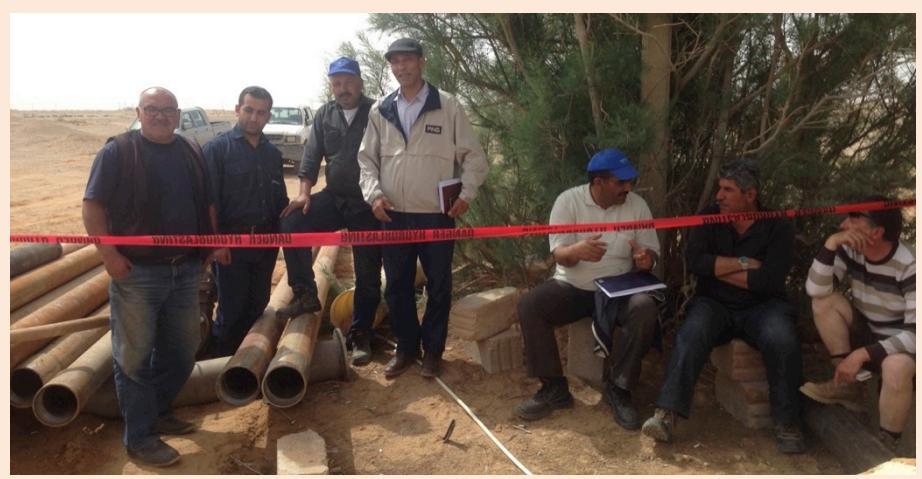
JPMC personnel observe high-pressure jetting from behind safety barrier

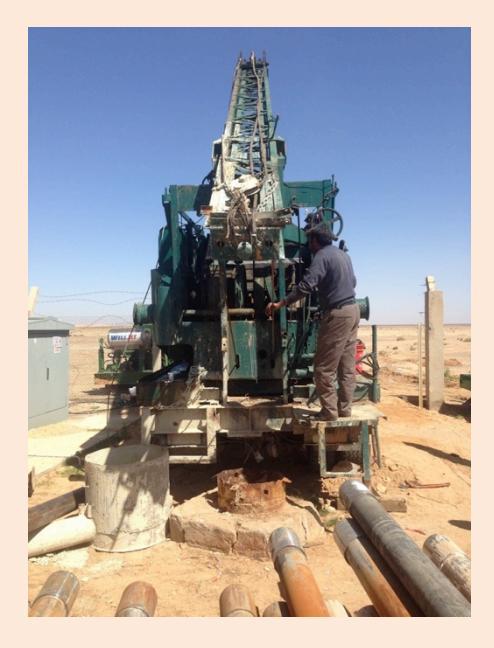
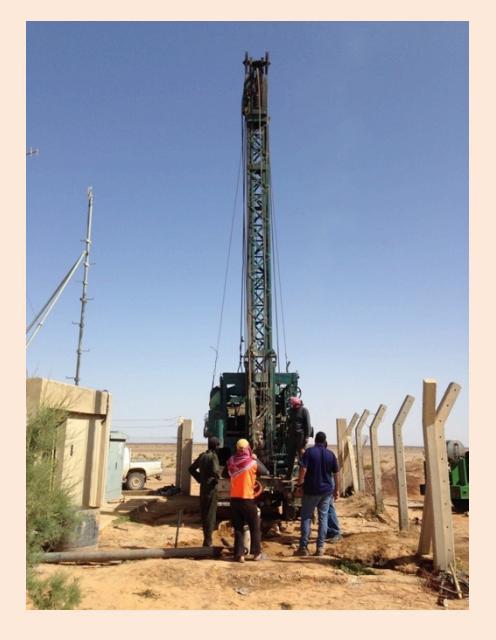
Jetting was followed by dual-swab surge-blocking and airlifting, to remove fill that came in from the jetting process. It was not unusual to see up to 40m (131') of material dislodged by jetting.

Because WellJet generates such tremendous energy out beyond the well screen into the gravel pack and near-wellbore formation, proper surging after jetting is essential to pull dislodged deposits into the well, from which they can be evacuated.

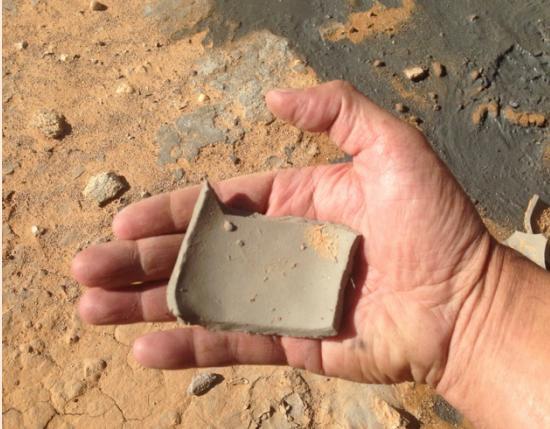
In the Eshidiya wells, the fill was typically a mixture of drill mud, fine sand, and iron scale:

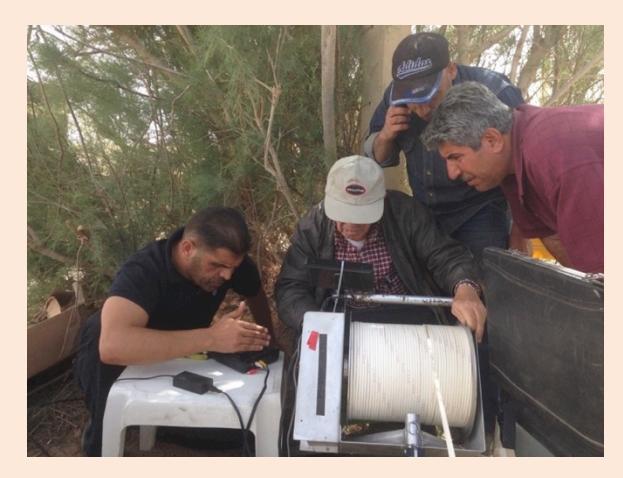
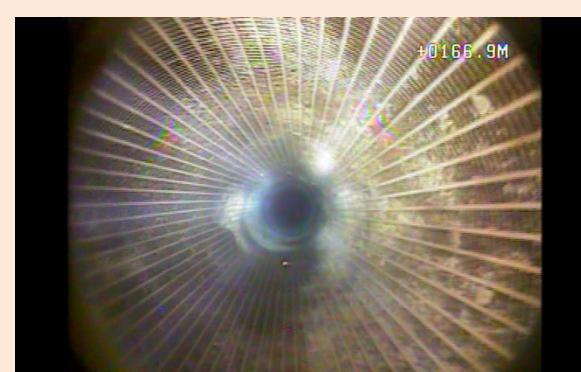
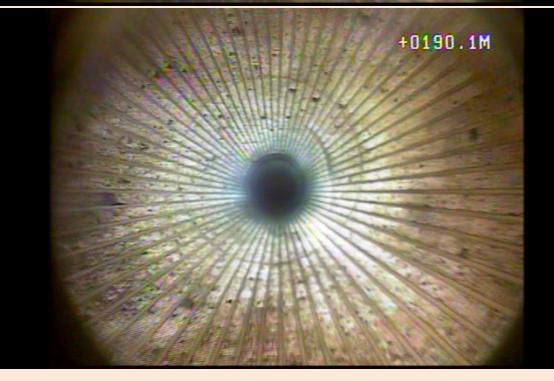
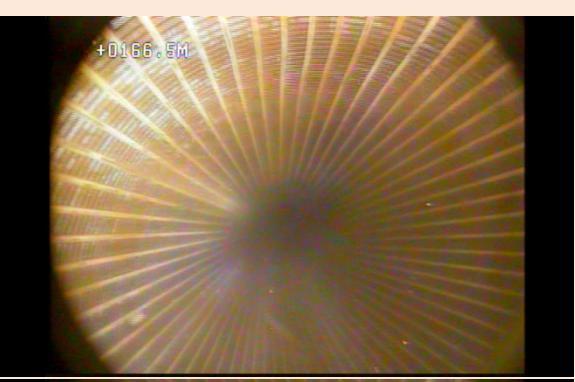
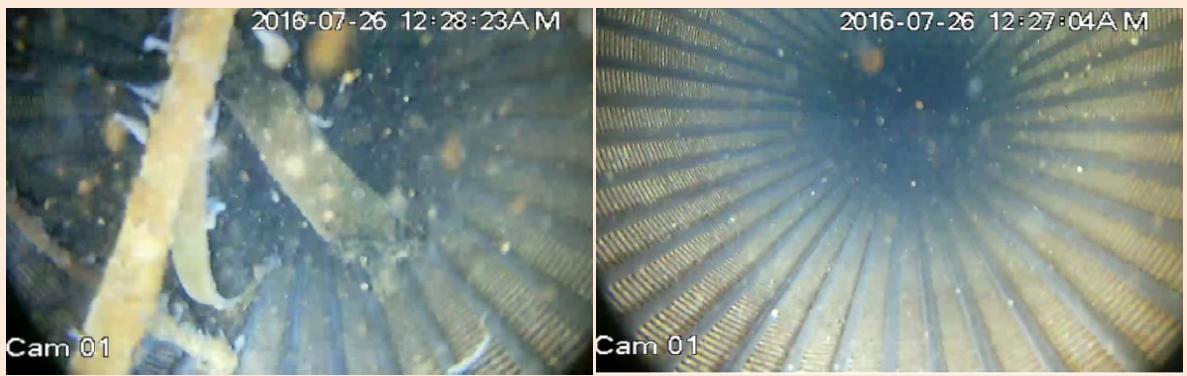
+0190.0M

Downhole video was recorded to provide Before/After visual comparison:

Before/After video shows how WellJet removed obstructions and opened plugged perforations.

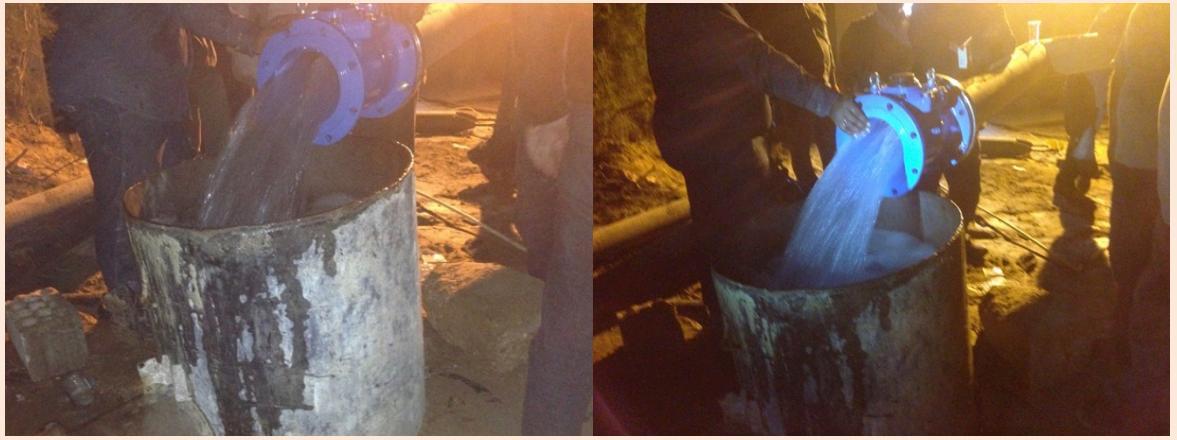
Following rehabilitation, test pumping was conducted to measure results. To enable a direct Before-and-After comparison, the exact same pump equipment, calibration and specifications were utilized and followed as prior to the rehabilitation:

At first, 20 minutes of black water...

Then clear.

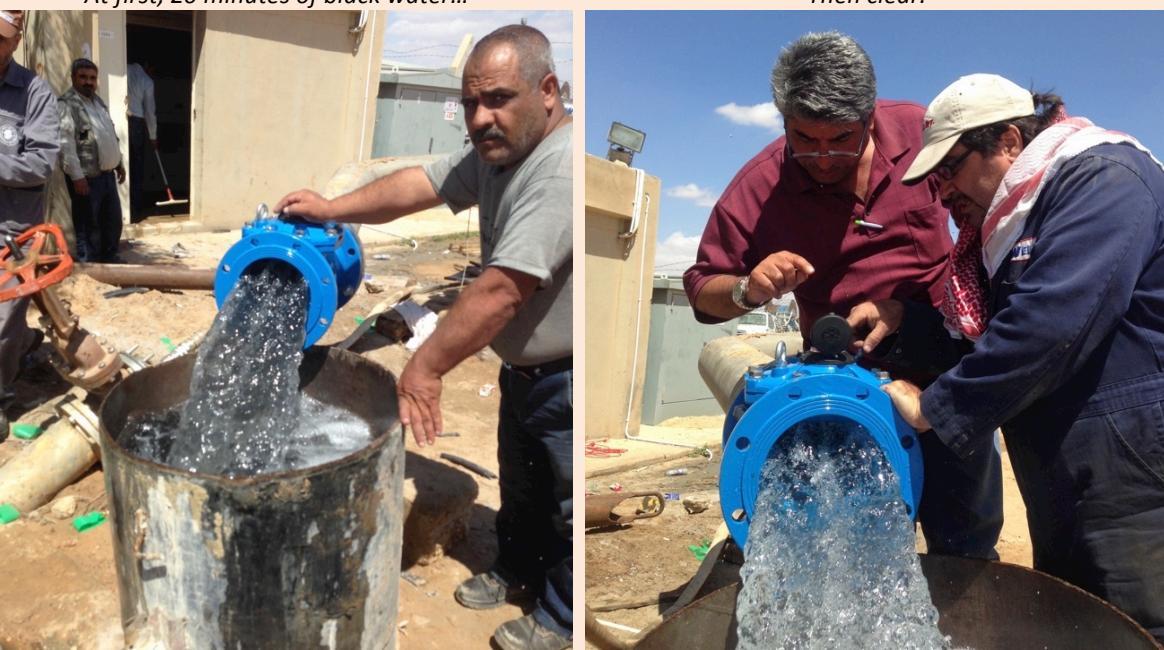
The next day, just 3 minutes of black water...

Then clear.

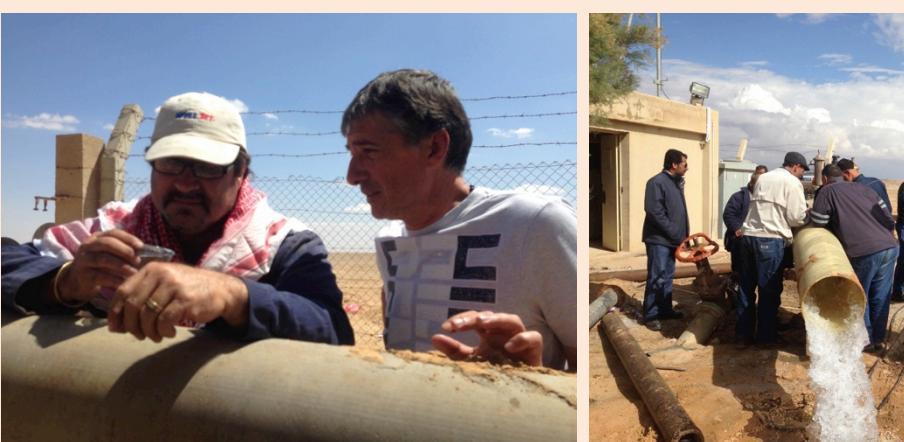
WellJet inventor Jeff Glass and KAC partner Mansour Khost examine flowmeter results.

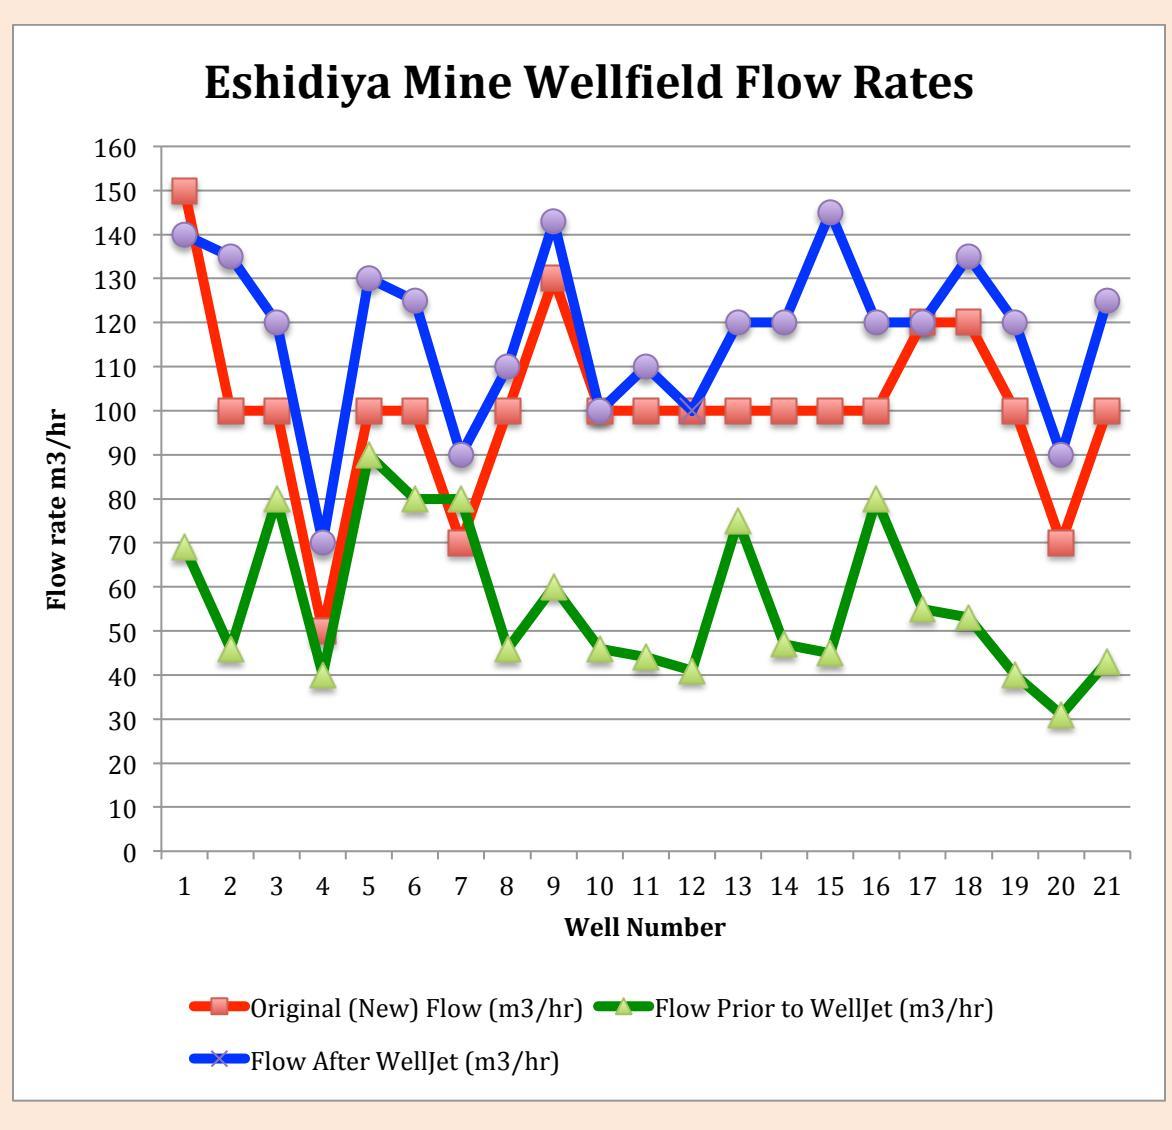
WELLJET-KAC RESULTS - JPMC ESHIDIYA WELLFIELD

When these 21 wells were drilled in 1991, their flow rates ranged from a low of 50 m3/hr (220 gpm) [Well #4] to a high of 150 m3/hr (660 gpm) [Well #1]. The average flow rate was 100 m3/hr (440 gpm).

By the time of the WellJet/KAC rehabilitation effort, flow rates had dropped to a high of 90 m3/hr (396 gpm) [Well #5], and a low of 31 m3/hr (136 gpm) [Well #20]. The average flow rate was just 57 m3/hr (251 gpm) – **an average decline of** -44 m3/hr (-194 gpm), or -42%.

After rehabilitation, flow rates improved from a low of 70 m3/hr (308 gpm) [Well #4], to a high of 145 m3/hr (638 gpm) [Well #15]. Average flow rate was 118 m3/hr (519 gpm). The average flow rate improvement was +61 m3/hr (+268 gpm), or +122%.

Comparing original flow rates when the wells were new, the WellJet/KAC rehabilitations improved flow an average of +17 m3/hr (+75 gpm), or +19%.

This flow rate improvement over original performance has taken place despite a decline in static water levels throughout the wellfield of approximately -6m (almost -20').
